# Seaworthy Inspection Report

Date of Survey 31 Jan 2025 10:18 AEDT

Reason For Survey Pre-Purchase Survey

Vessel Make and Model Caribbean Safari

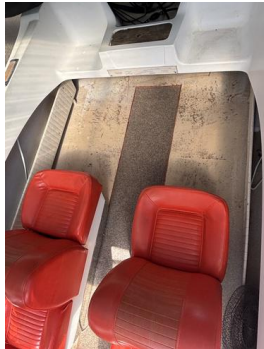
Photo 13

Solid underfoot all round  
Centre of deck area recently restored - professional job

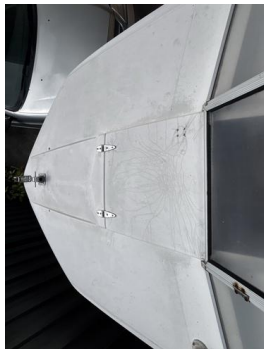
Photo 14

UV damage and paint cracks

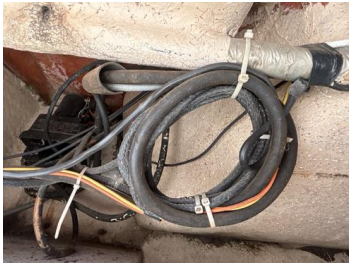
Photo 19

Fuel lines aged

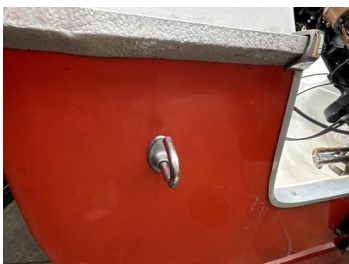
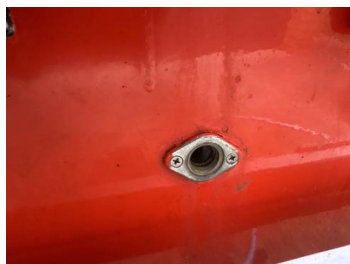
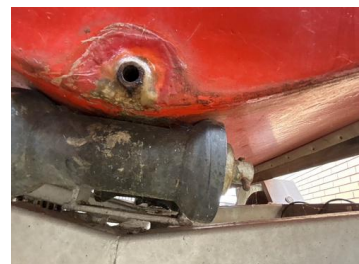
Bung lower Penetration could be resealed

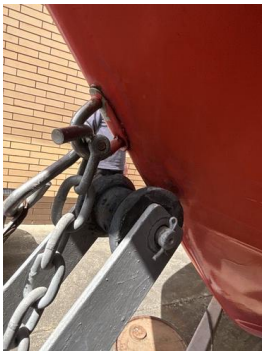
Photo 26

Loose

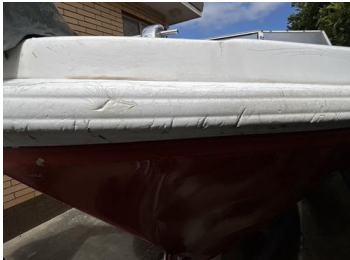
Photo 27

Scuffs cuts and some age cracking mostly intact all around

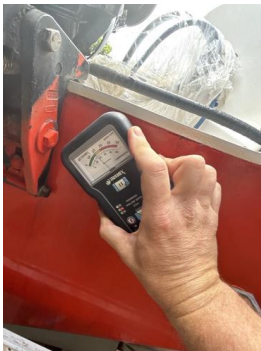
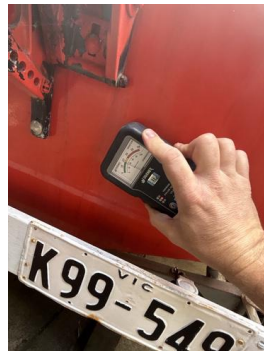
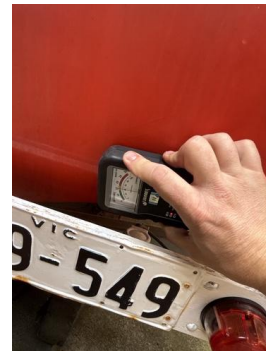
No flex detected

Percussion testing showing no signs of delamination - transom exceptional condition for age of vessel

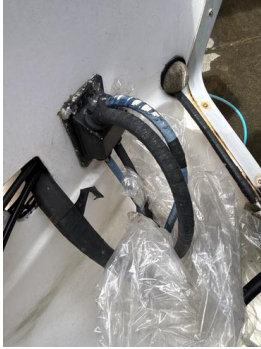
Photo 63

External sheeting UV damaged - smooth operation.

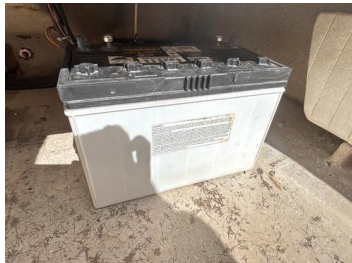
Photo 71

Battery charged with 80% life on test.

No

Recommend battery bracket to be installed

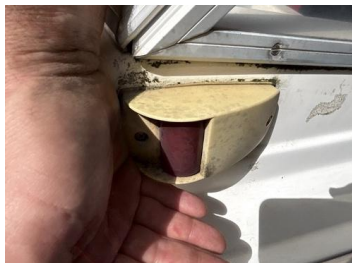
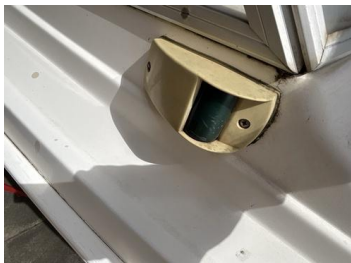
Aged with UV damage

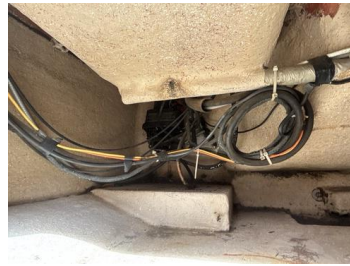
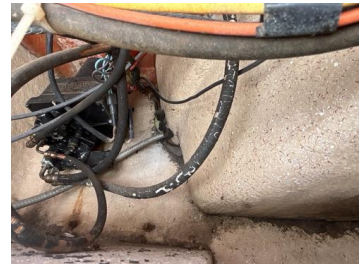
Overall basic functional however aged wiring.
