## **HULL AND CONDITION SURVEY**

### **“ARC-EN-CEIL”**

**ROYAL FRESHWATER BAY YACHT CLUB**

**25<sup>TH</sup> OCTOBER 2023**

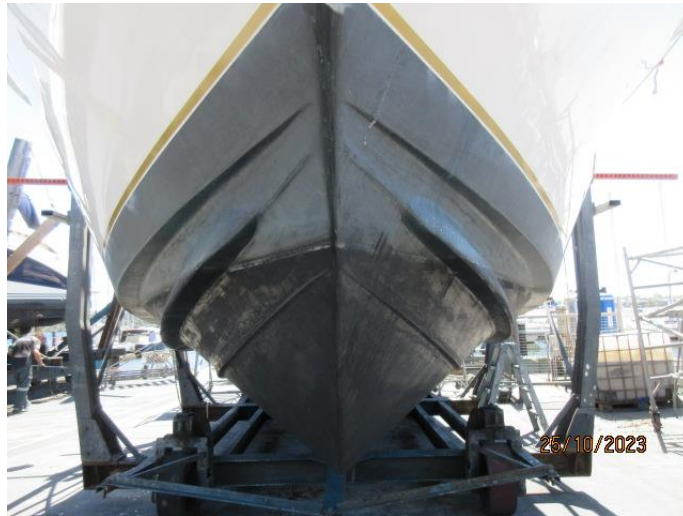
Figure 4 – Stem

| No. | ITEM | GOOD | FAIR | POOR | DEFECT<br>YES | DEFECT<br>NO | REMARKS |
|---|---|---|---|---|---|---|---|
| 1.14 | Stem | X | | | | X | In apparent good order |

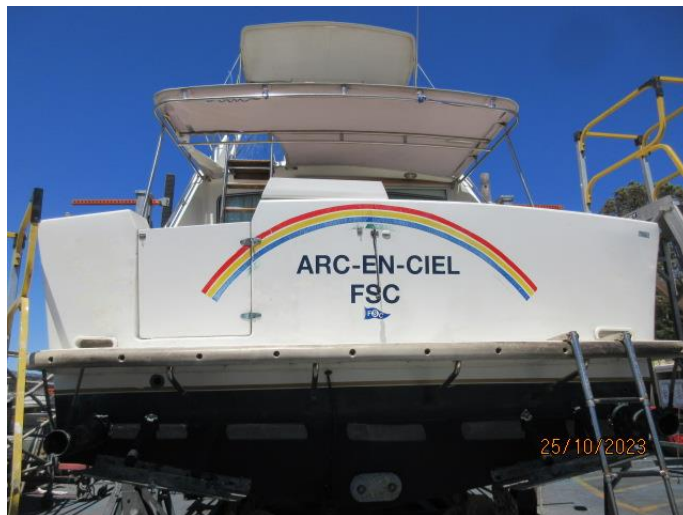
Figure 5 – Stern

| No. | ITEM | GOOD | FAIR | POOR | DEFECT<br>YES | DEFECT<br>NO | REMARKS |
|---|---|---|---|---|---|---|---|
| 1.11 | Transom | X | | | | X | In apparent good condition |

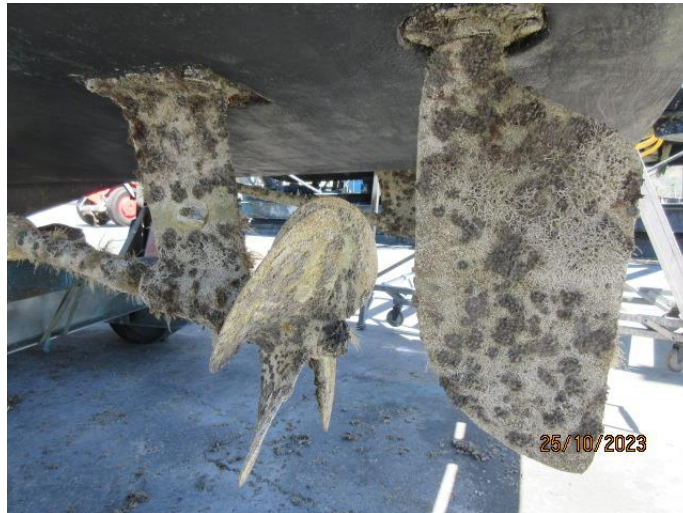
Figure 10 – Port side propeller / rudder

| No. | ITEM | GOOD | FAIR | POOR | DEFECT<br>YES | DEFECT<br>NO | REMARKS |
|---|---|---|---|---|---|---|---|
| 1.15 | Rudder | X | | | | X | In good order and condition |
| 1.17 | Propeller/s | X | | | | X | Full bodied no apparent pitting or wastage |

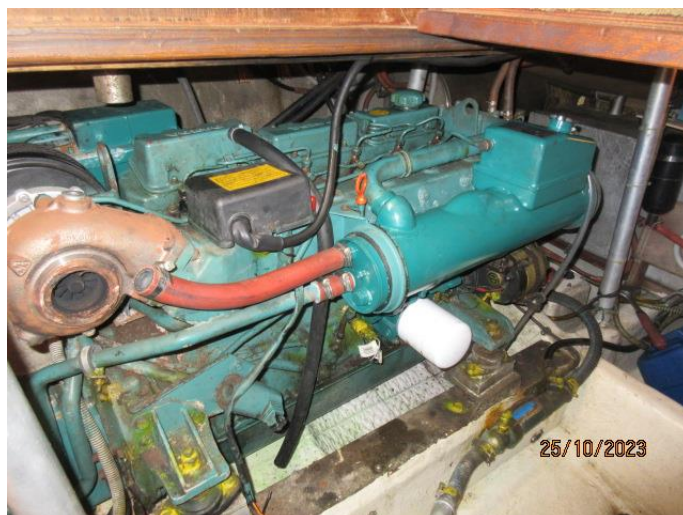
Figure 12 – Port side engine

| No. | ITEM | GOOD | FAIR | POOR | DEFECT YES | DEFECT NO | REMARKS |
|---|---|---|---|---|---|---|---|
| 3.1 | Installation | X | | | | X | In apparent good order and condition. Well maintained |

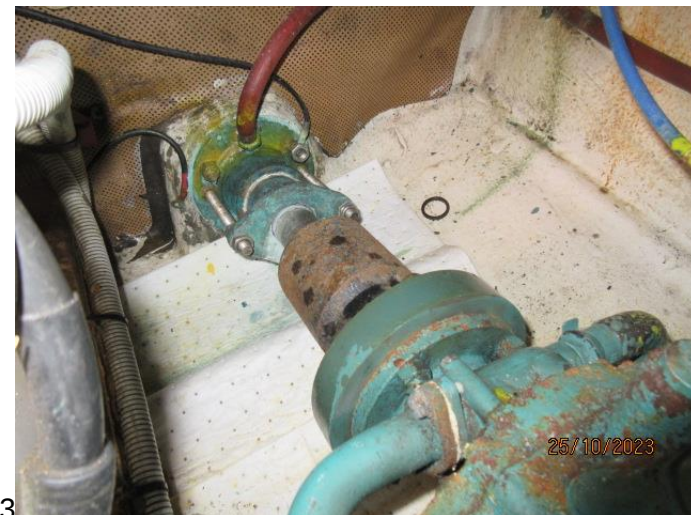
Figure 14 – Port side stern gland

| No. | ITEM | GOOD | FAIR | POOR | DEFECT<br>YES | DEFECT<br>NO | REMARKS |
|---|---|---|---|---|---|---|---|
| 2.13 | Stern gland/s | X | | | | X | In apparent good order |

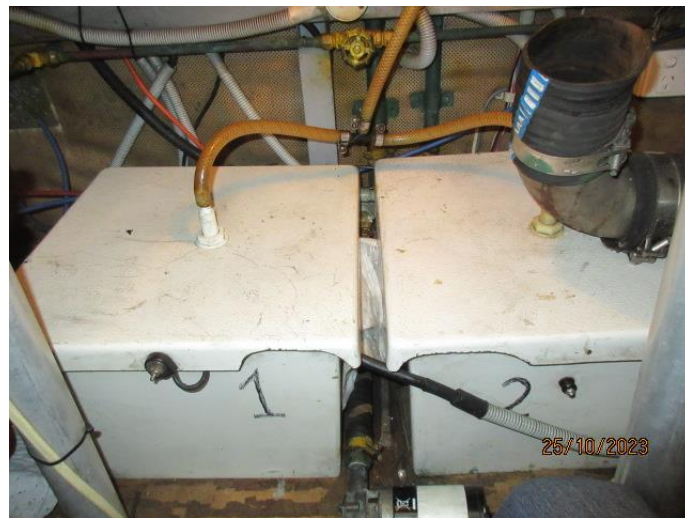
Figure 16 – Battery bank

| No. | ITEM | GOOD | FAIR | POOR | DEFECT YES | DEFECT NO | REMARKS |
|---|---|---|---|---|---|---|---|
| 3.17 | Batteries | X | | | | X | In good condition |
| 3.18 | Mounting | X | | | | X | Firm and secure |

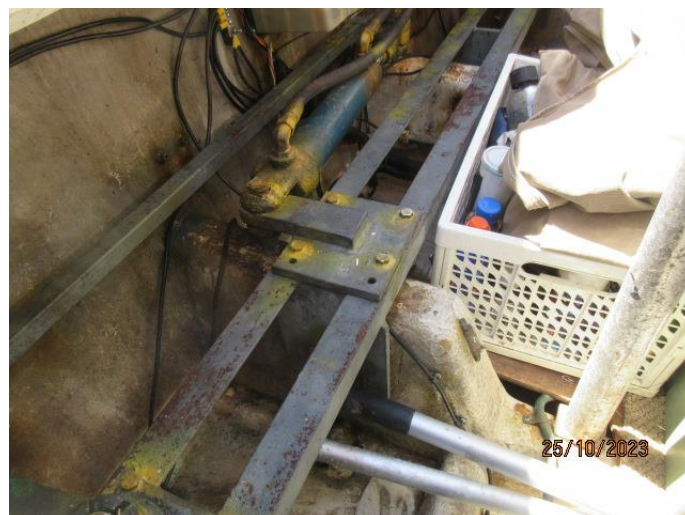
Figure 17 – Steering linkage

| No. | ITEM | GOOD | FAIR | POOR | DEFECT<br>YES | DEFECT<br>NO | REMARKS |
|---|---|---|---|---|---|---|---|
| 2.17 | Steering linkage | X | | | | X | In good order with no apparent play. |

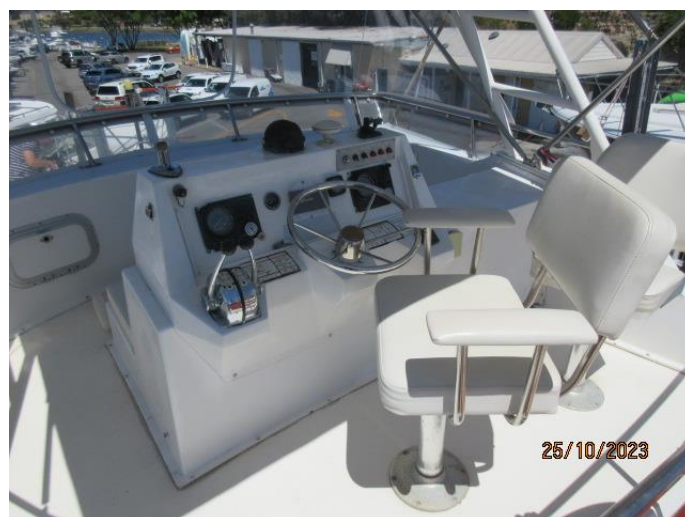
Figure 18 – Flybridge helm

It was noted that the PLASTIMO compass on the fly bridge was not functional.

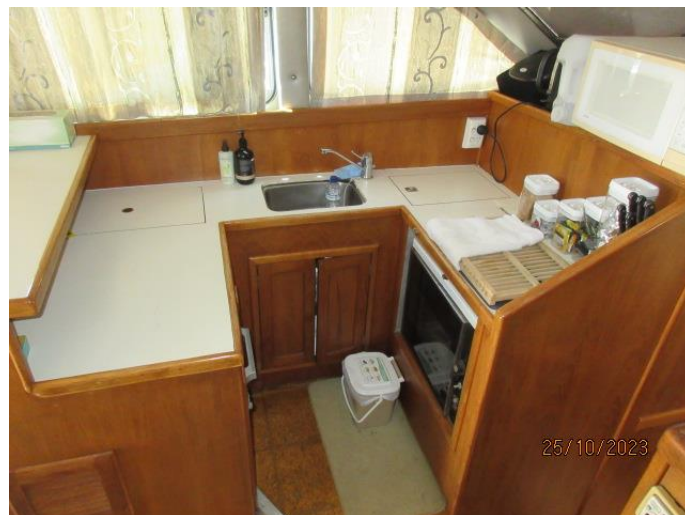
Figure 20 – Galley

The owner advised that the gas stove is disconnected and never used. No gas bottle was installed/connected or in place for the stove at the time of the survey.

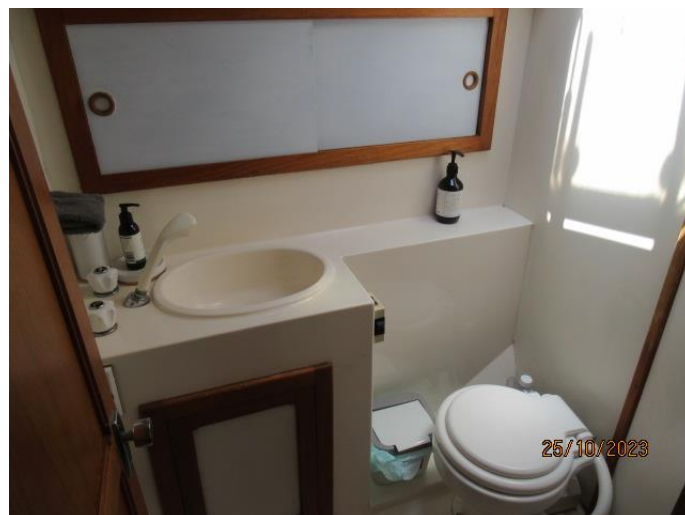
Figure 23 – Toilet

| No. | ITEM | GOOD | FAIR | POOR | DEFECT<br>YES | DEFECT<br>NO | REMARKS |
|---|---|---|---|---|---|---|---|
| 2.21 | Toilet | X | | | | X | In apparent good order but not tested. |

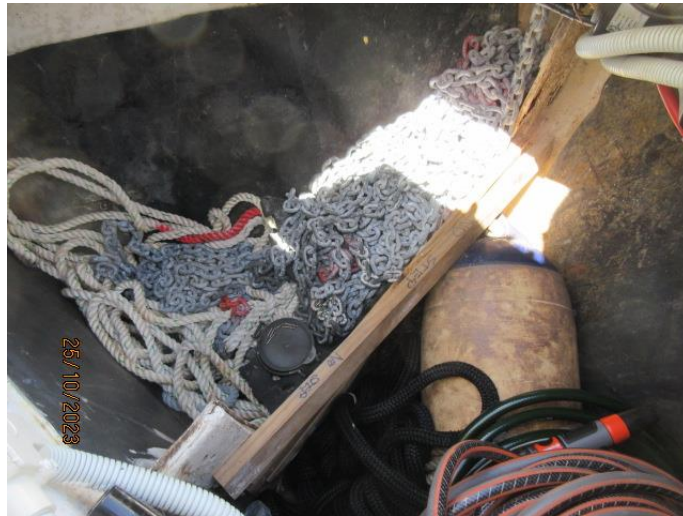
Figure 25 – Chain locker

| No. | ITEM | GOOD | FAIR | POOR | DEFECT YES | DEFECT NO | REMARKS |
|---|---|---|---|---|---|---|---|
| 6.10 | Chain locker & bulkhead | X | | | | X | In good order with no apparent cracking |
