# PRE-PURCHASE INSPECTION OUT OF WATER

2007 Sea Ray 270

| Date | 03/03/2026 |

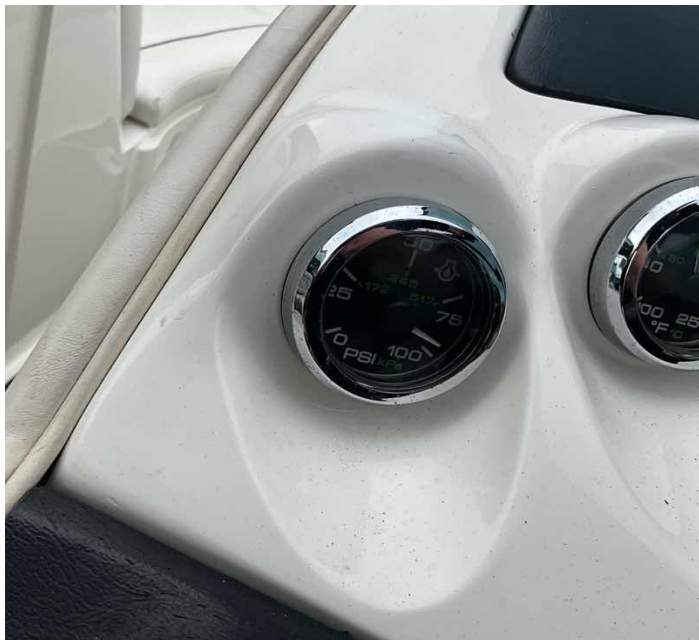
| Instrument Panel | Oil pressure, temperature, speedo, tacho, trim and fuel gauges | Comments | Oil pressure appears faulty<br>Remainder operational |

| Oil Pressure At Idle | Gauge appears out of order | Oil Pressure At WOT | Gauge appears out of order |
| Gauges | Oil pressure sensor appears faulty | Temperature | 80°C |

- H1. Oil pressure sender appears faulty, showing 90PSI constantly and does not change
- H2. Heavy external corrosion to front of engine surrounding power steering pulleys, recommend cleaning and treating

H1. Oil pressure sender appears faulty

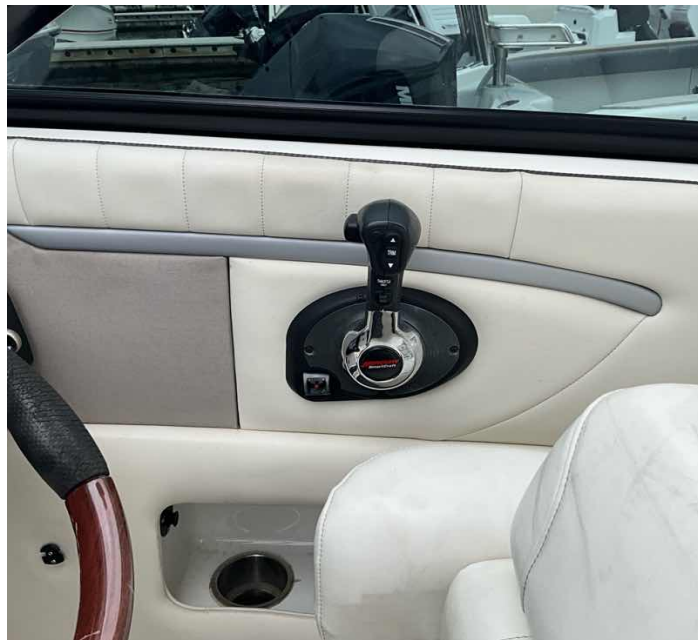
- M1. Engine alarm sounding when put into reverse, recommend further diagnosis
- M2. External corrosion to heat exchanger, recommend removal and repairing
- M3. Corrosion to exhaust manifold and riser gasket, unknown history of exhaust elbows. Recommend removal and inspection due to age
- M4. Toilet vacuum hose perished, recommend replacement
- M5. Alternator voltage low when engine running (11.6V), recommend further diagnosis

M1. Engine alarm sounding when put into reverse

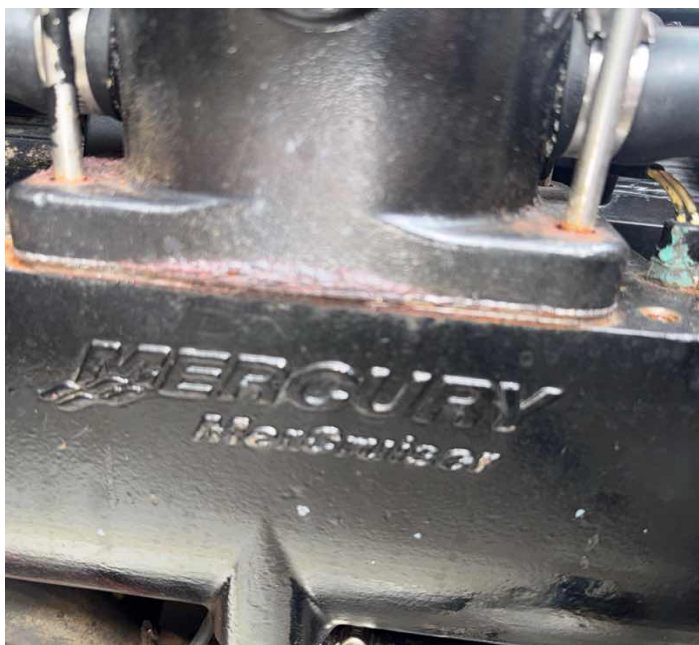
| Exhaust Manifolds | External corrosion noted<br>Recommend removal and inspection | Engine Warning Alarm | Operational |

M3. Corrosion to exhaust manifold and riser gasket

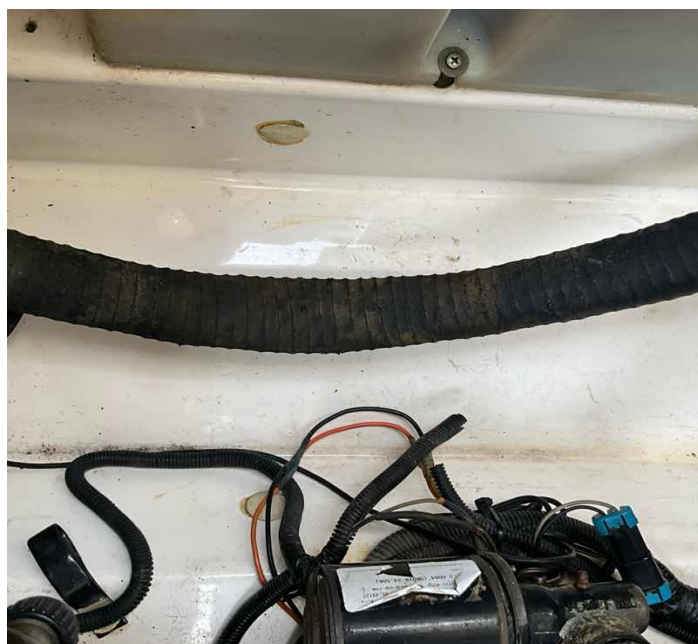
M4. Toilet vacuum hose perished

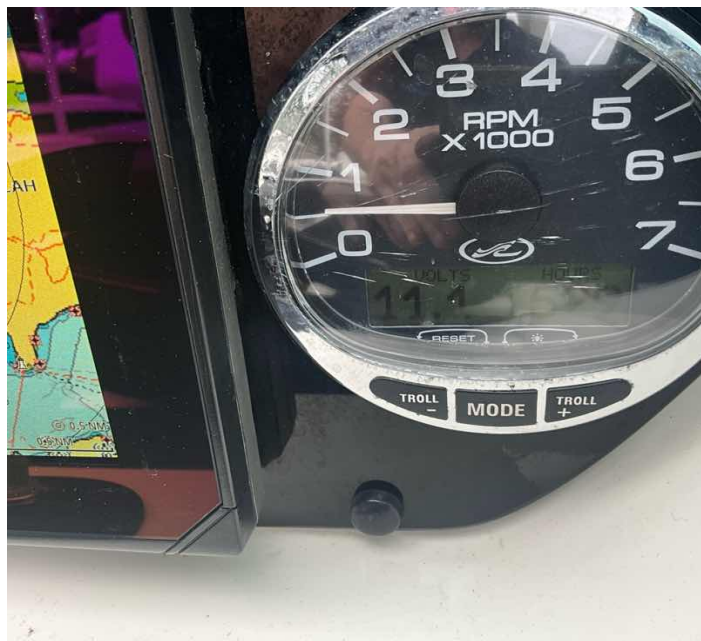
| Alternator Voltage | 12.8V<br>Recommend further diagnosis | Top Speed | 31 Knots |

M5. Alternator voltage low when engine running (11.6V)

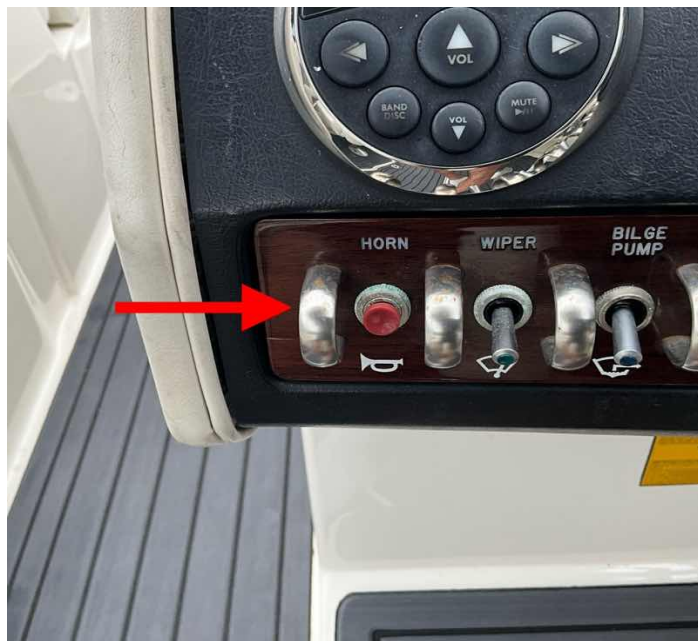
| Sound Signal | 1, out of order | Floating Waterproof Torch | 0 |

L1. Horn out of order

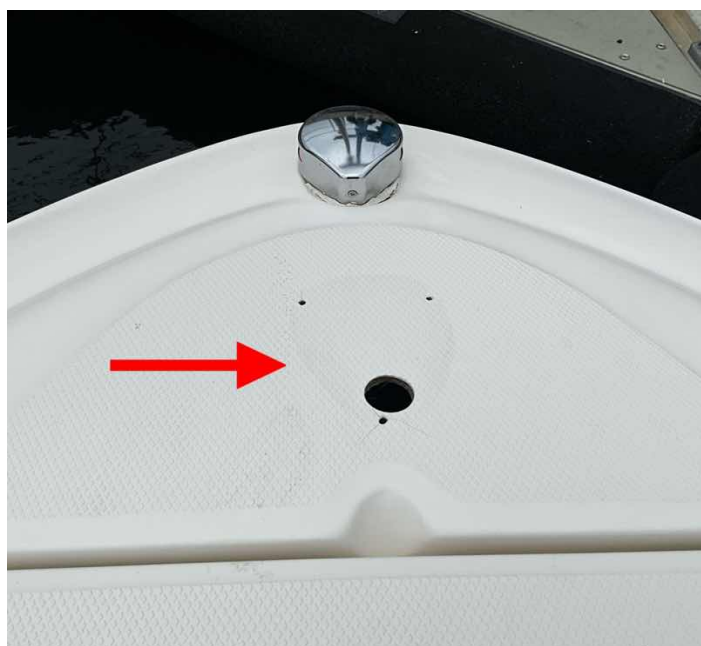
L2. Unsealed holes to bow

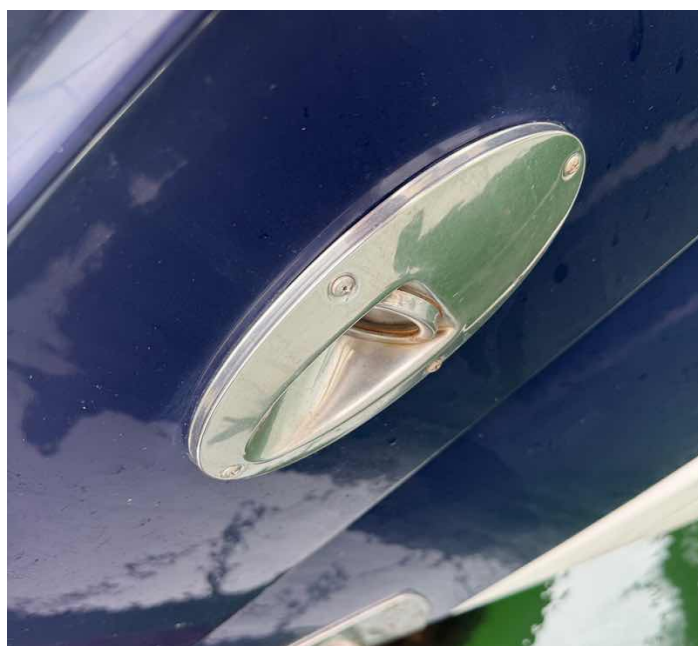
L3a. Docking lights out of order

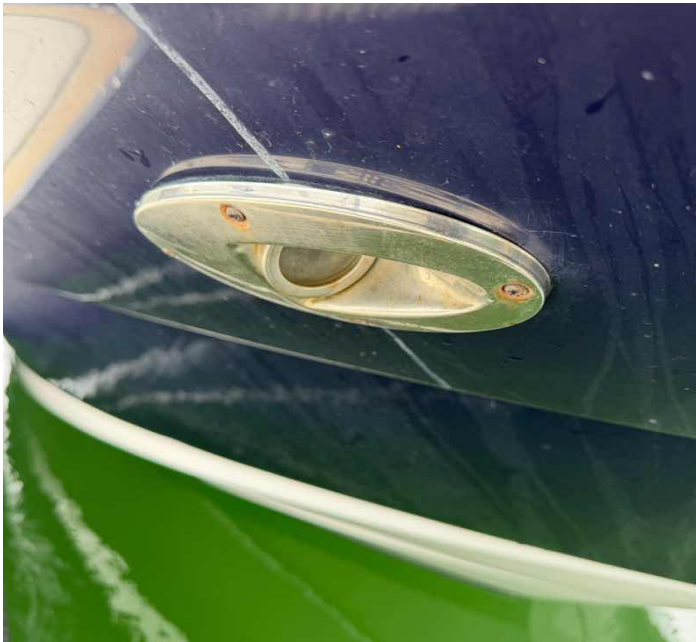
L3b. Docking lights out of order

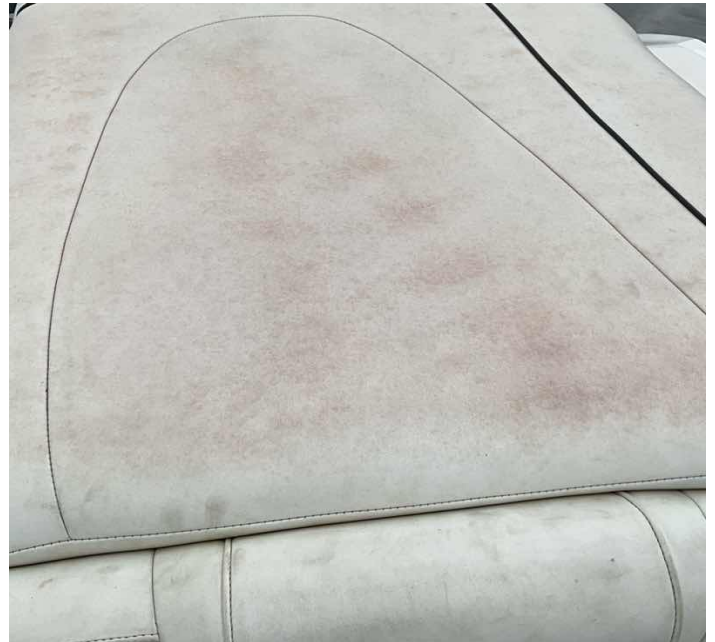
L4. Fading to rear upholstery

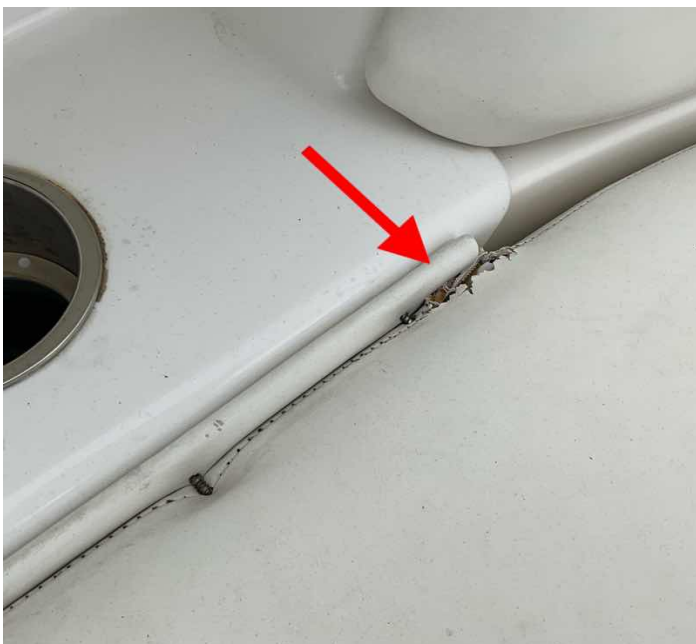
L5a. Damage to FWD upholstery

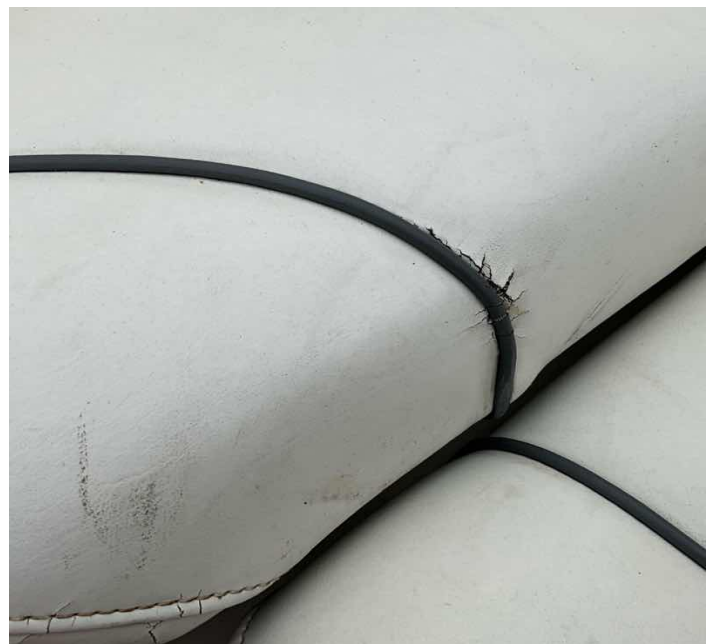
L5b. Damage to FWD upholstery

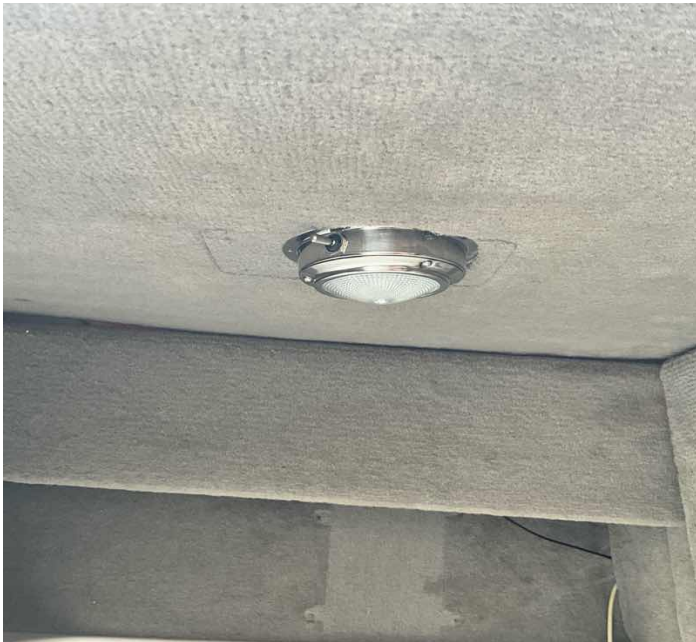
L6. Starboard side storage locker light out of order

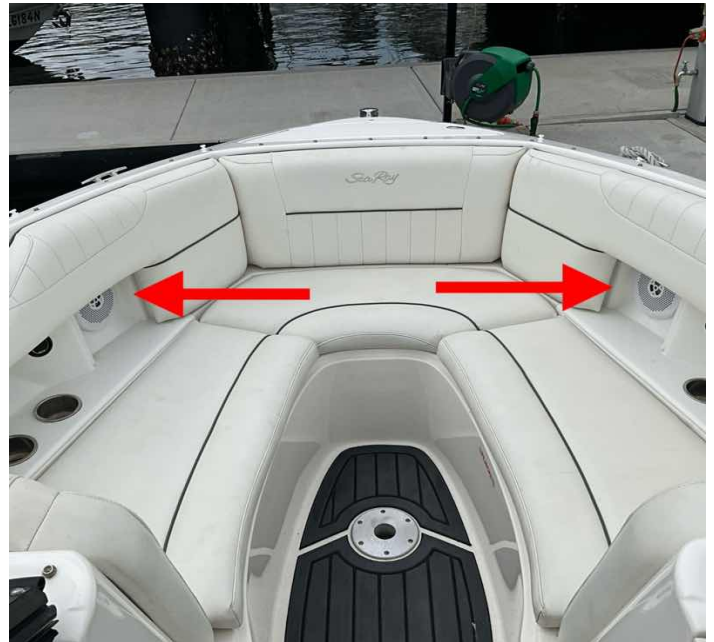
L7. 2x FWD speakers would not power on

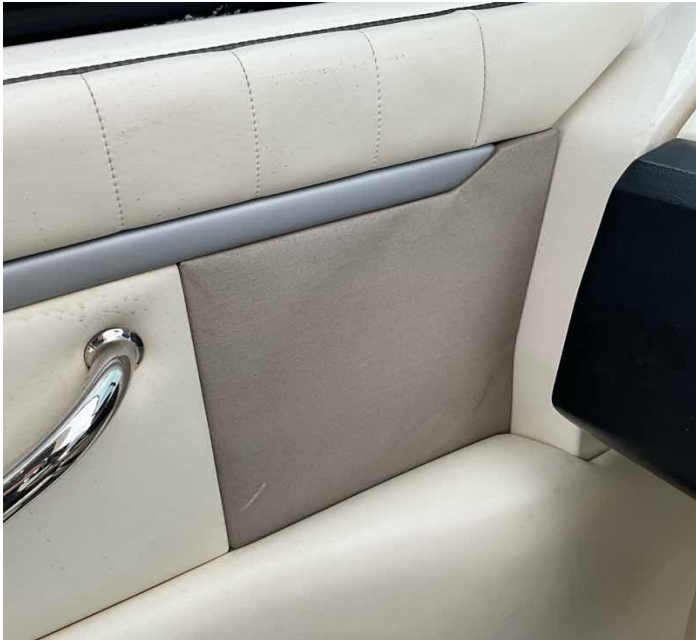
L8. Port side cockpit speaker out of order

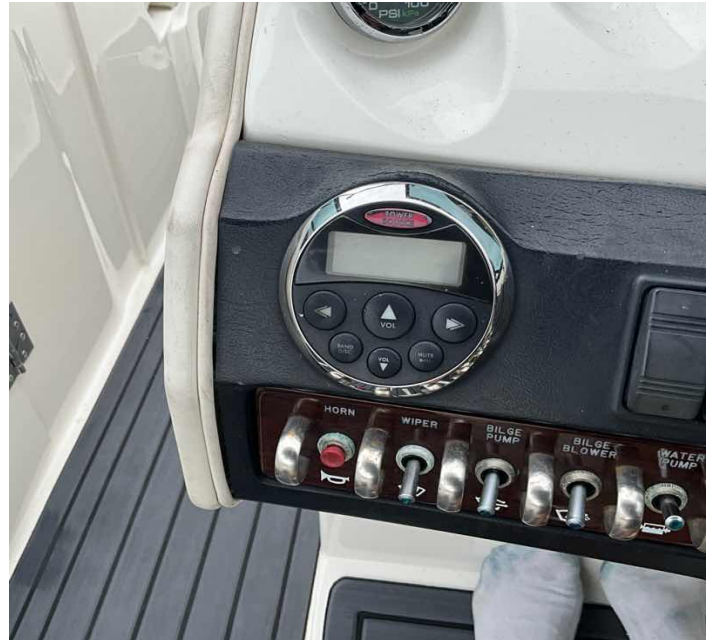
L9. Clarion stereo redundant

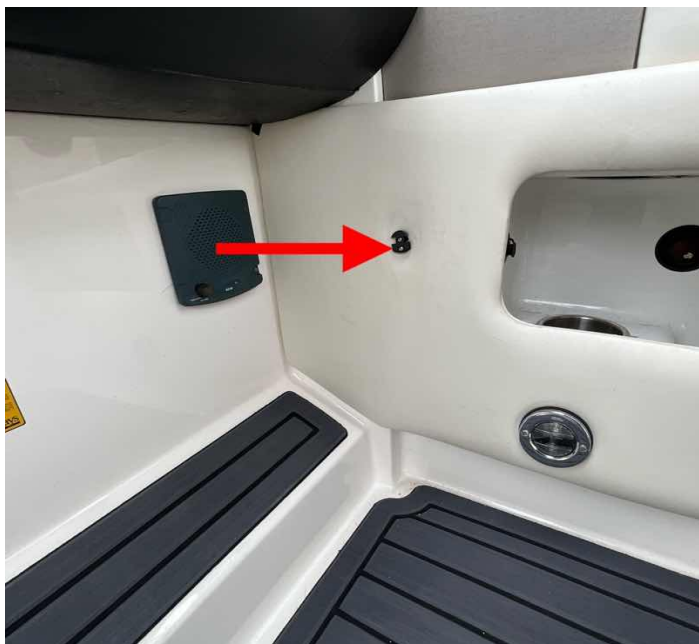
L10. VHF transmitter missing

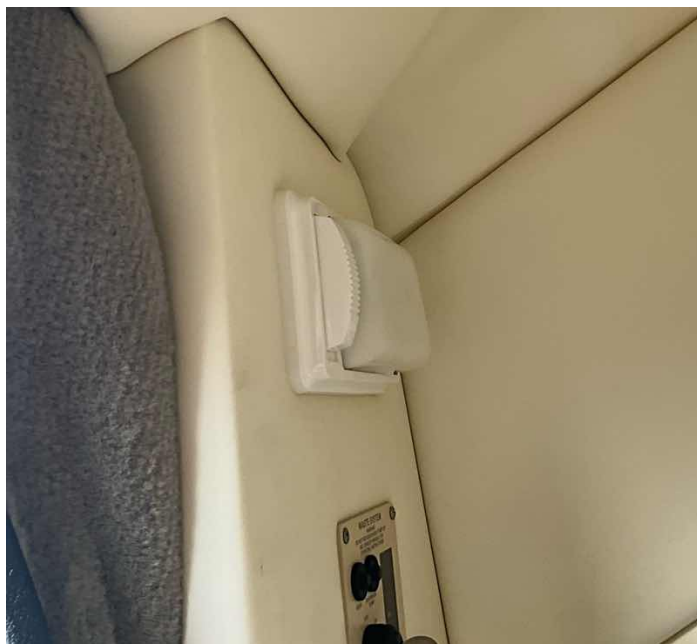
L11. Toilet courtesy light would not power on

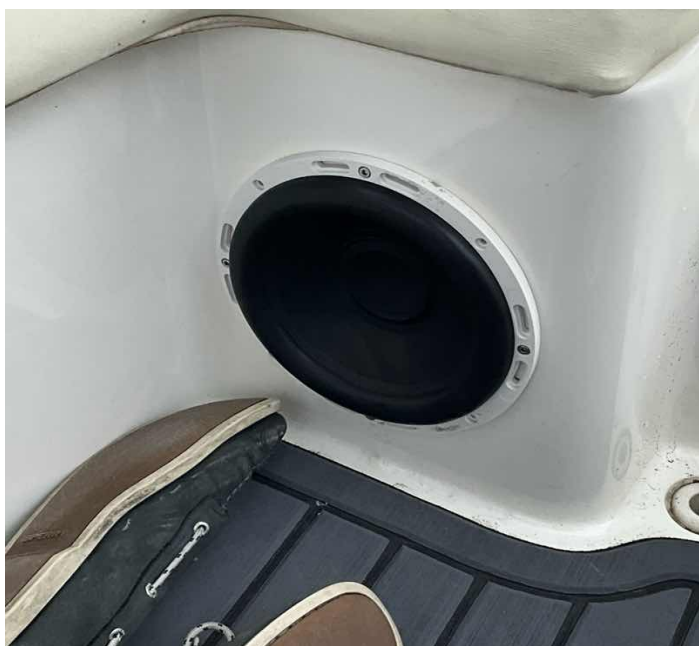
L12. Starboard rear speaker missing cover

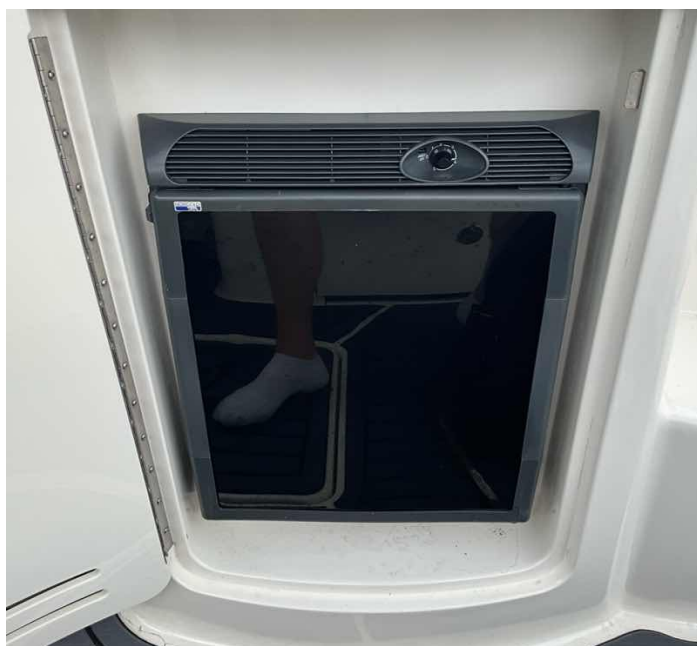
L13. Norcold fridge would not power on

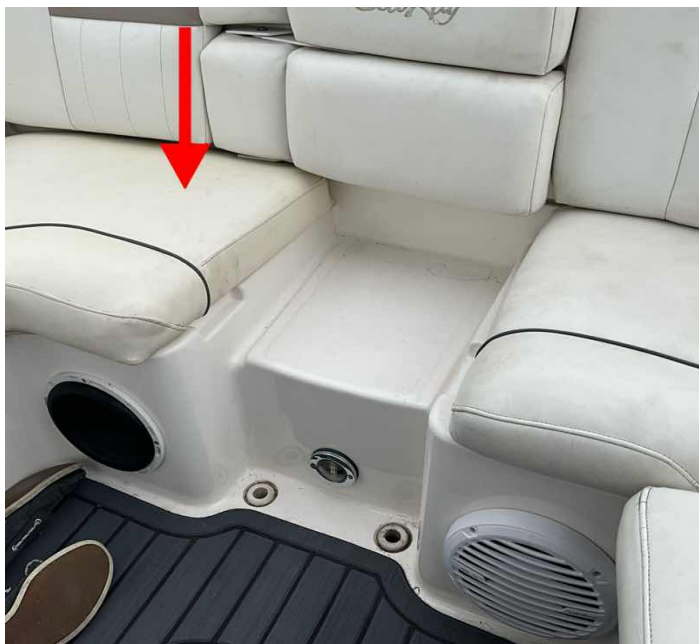
L14. Starboard side rear cushion appears different colour to remainder of trim

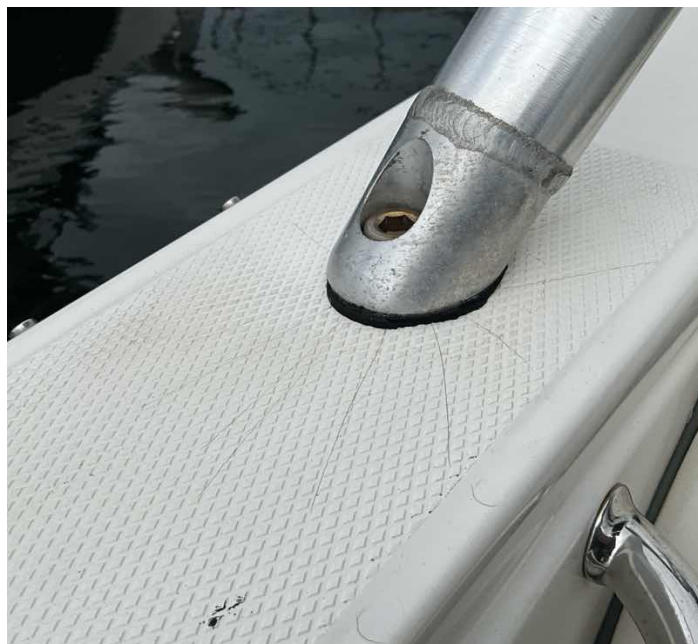
L15. Spider cracking surrounding gelcoat to tower

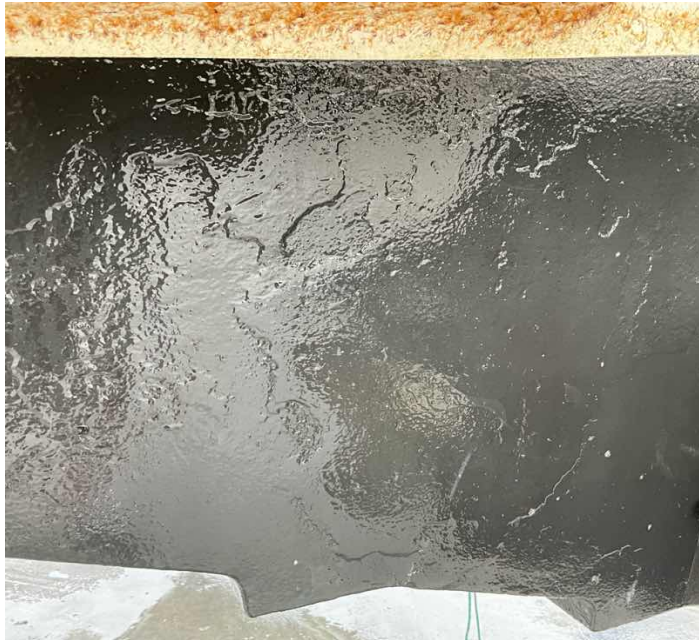
L16. Large build up of antifoul noted

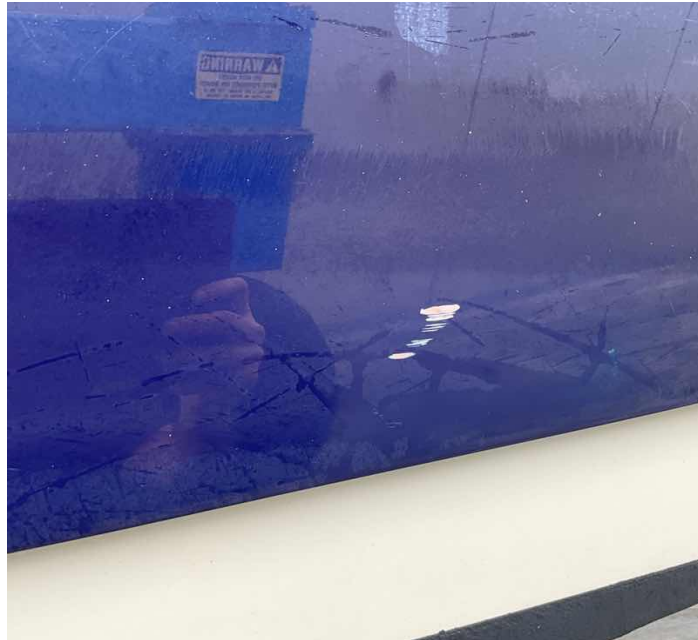
L17a. Various gouges to gelcoat on boat hull sides

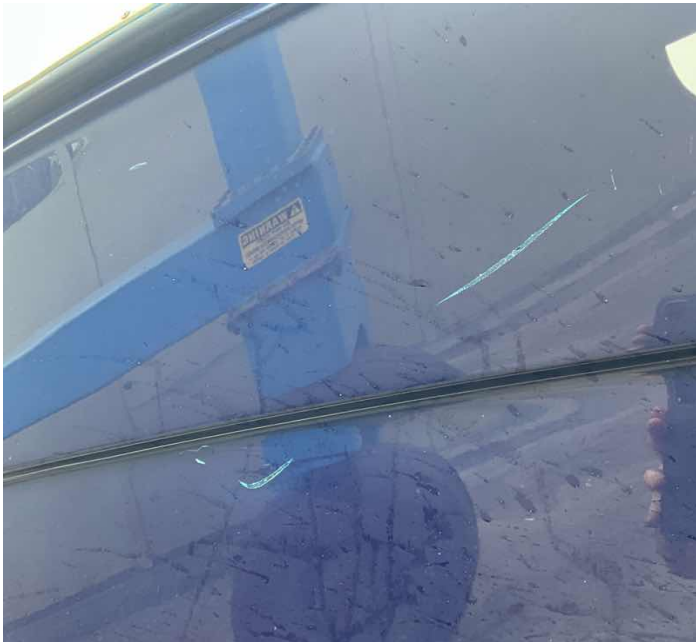
L17b. Various gouges to gelcoat on boat hull sides

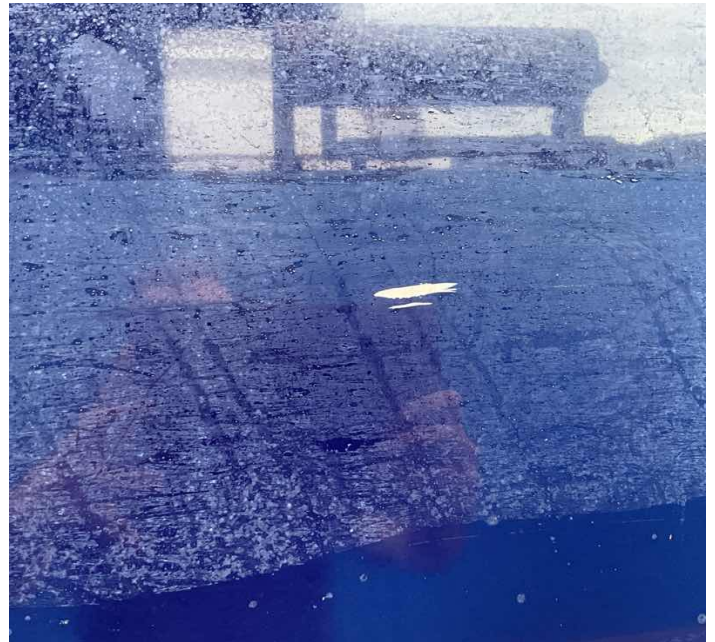
L17c. Various gouges to gelcoat on boat hull sides

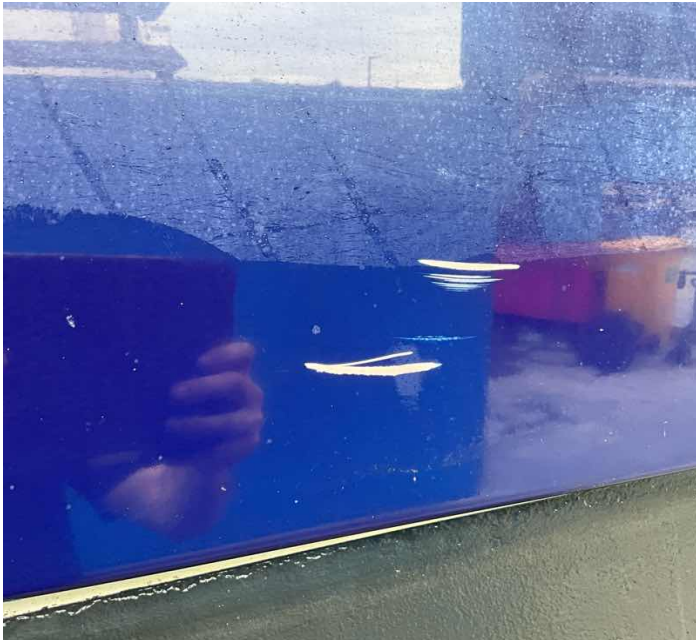
L17d. Various gouges to gelcoat on boat hull sides

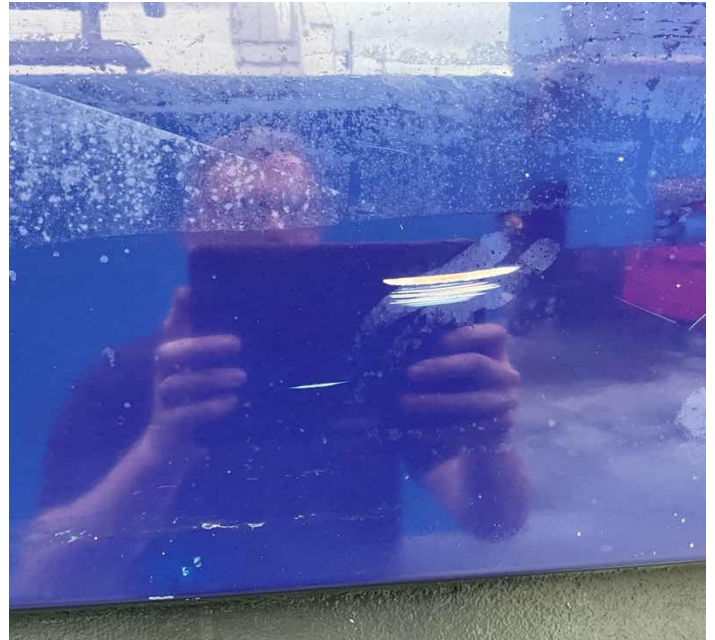
L17e. Various gouges to gelcoat on boat hull sides

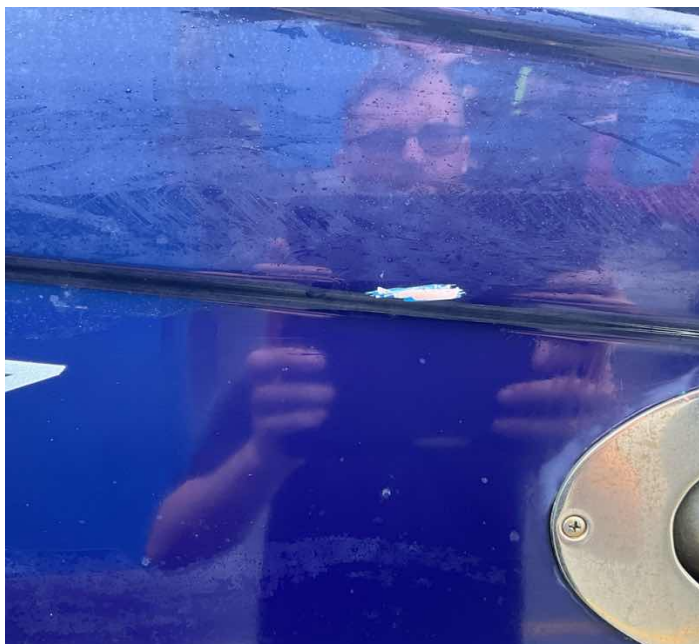
L17f. Various gouges to gelcoat on boat hull sides

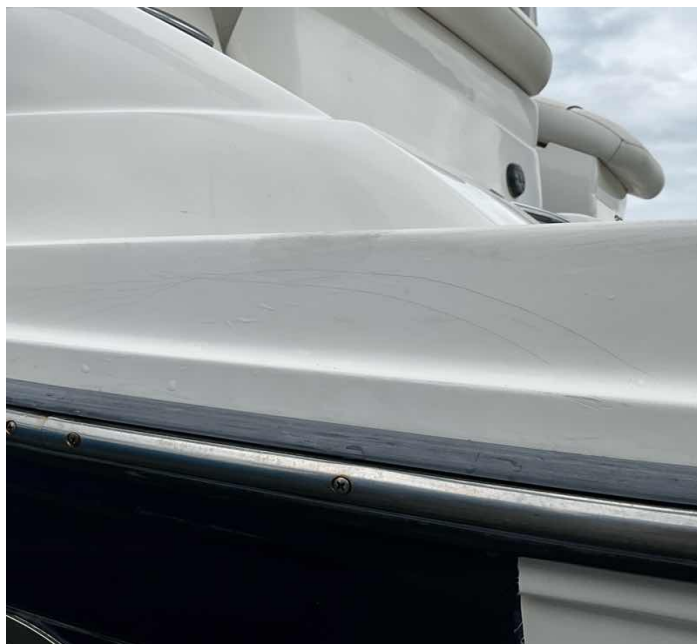
L18. Spider cracking to port side aft corner

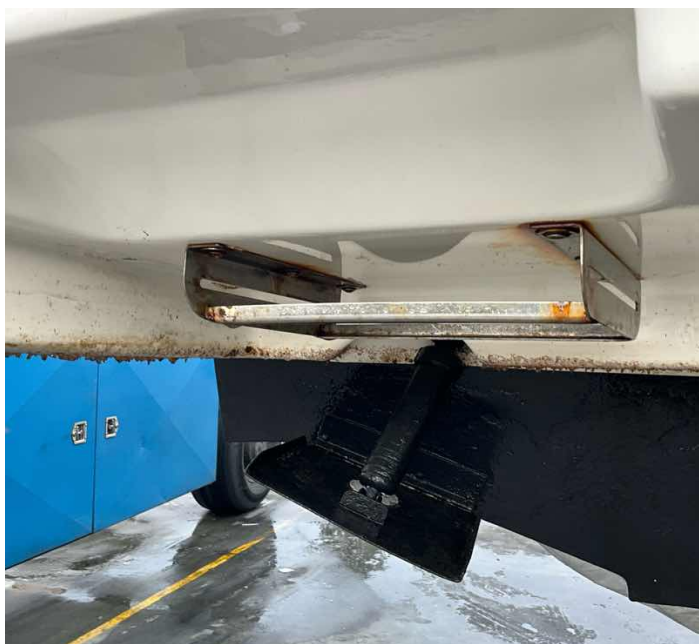
L19a. Swim platform ladder has been removed and replaced with aftermarket

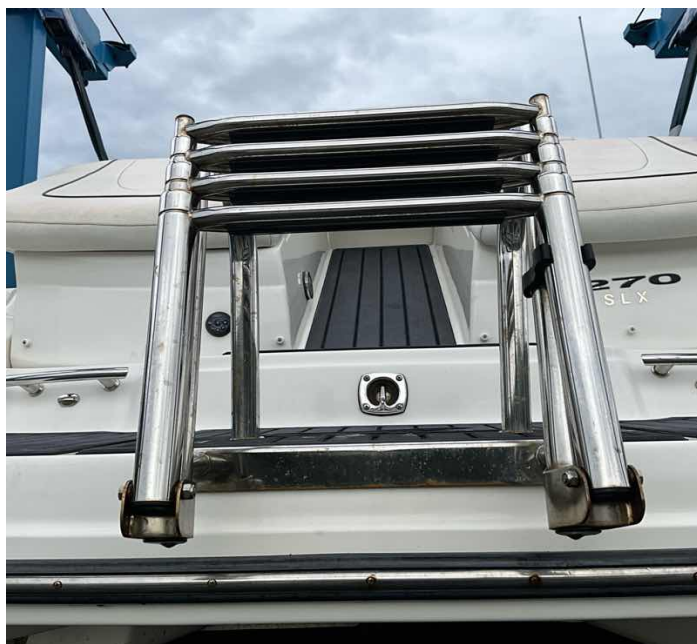
L19b. Swim platform ladder has been removed and replaced with aftermarket

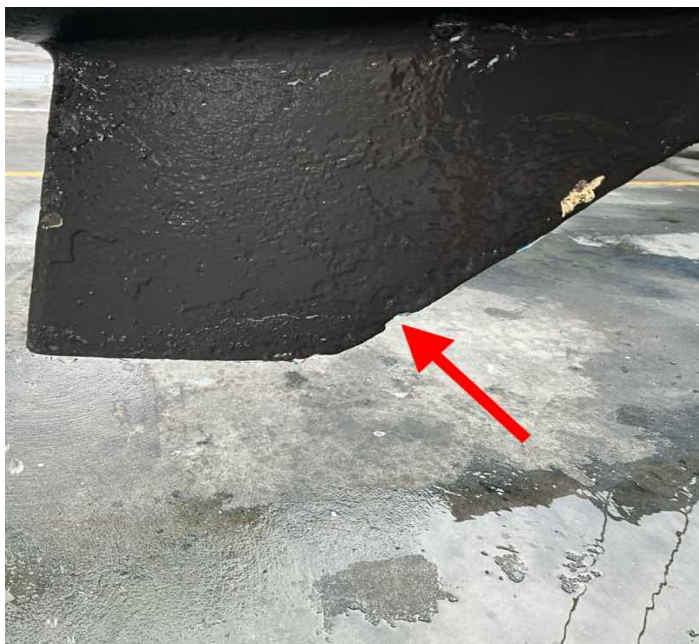
L20. Minor chips to sterndrive skag

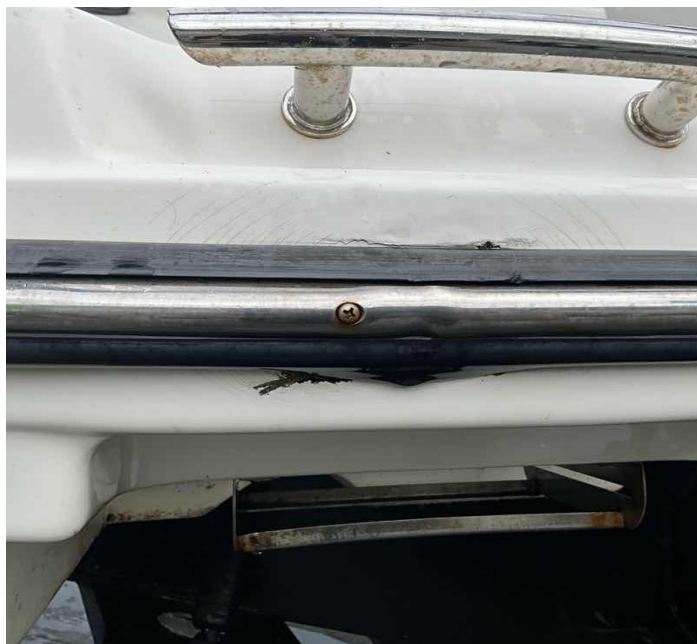
L21. Impact damage to port side aft corner of gunnel

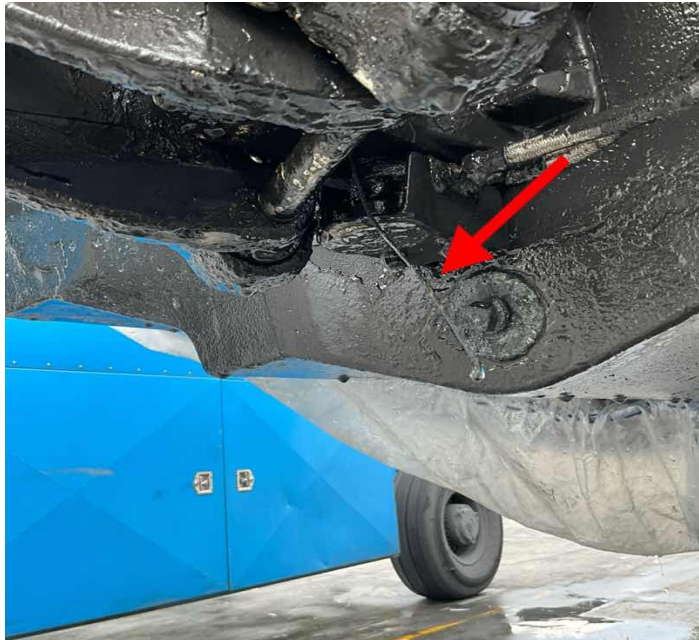
L22. Sterndrive earth strap detached

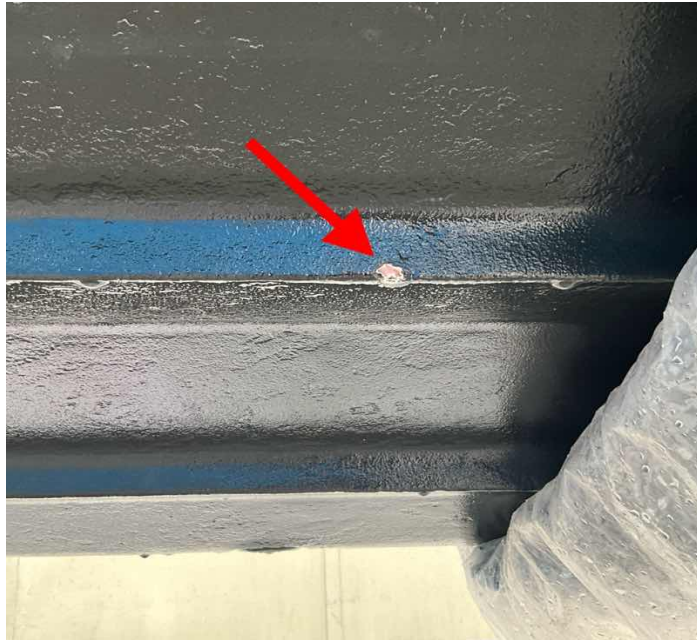
L23. Gelcoat gouge to port side strake beneath waterline

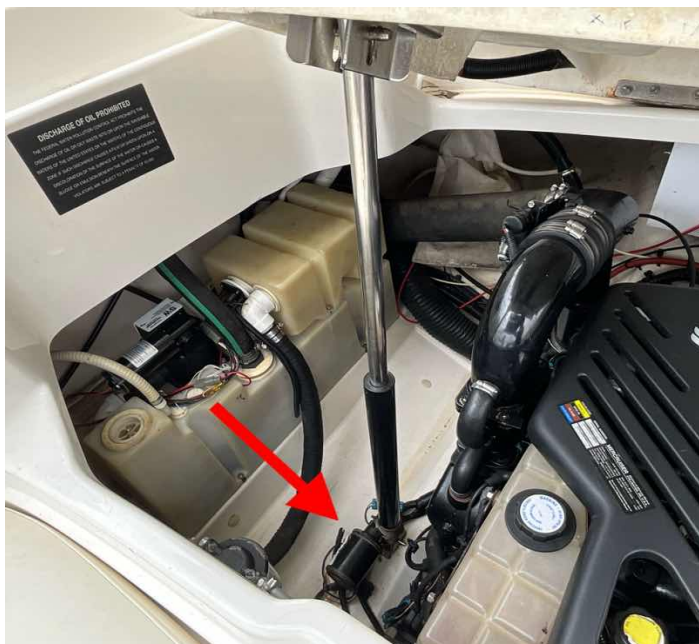
L25. Engine hatch intermittently would not lift

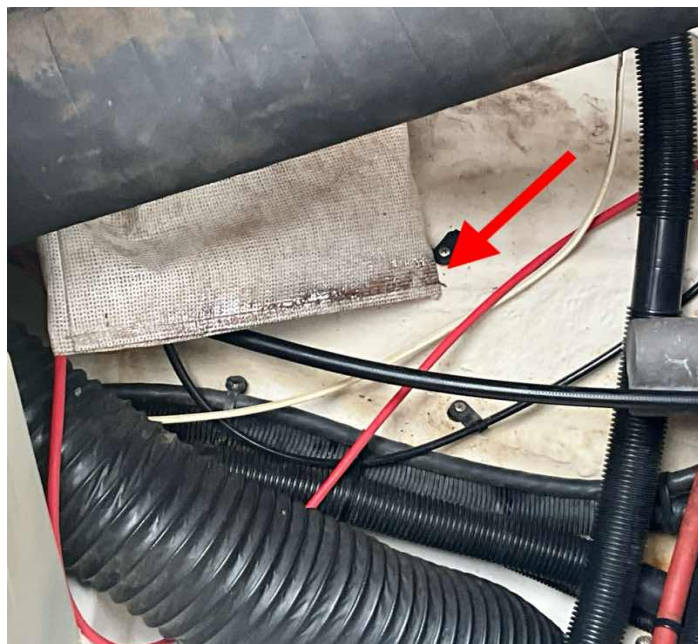
L27. Transom shower leaking

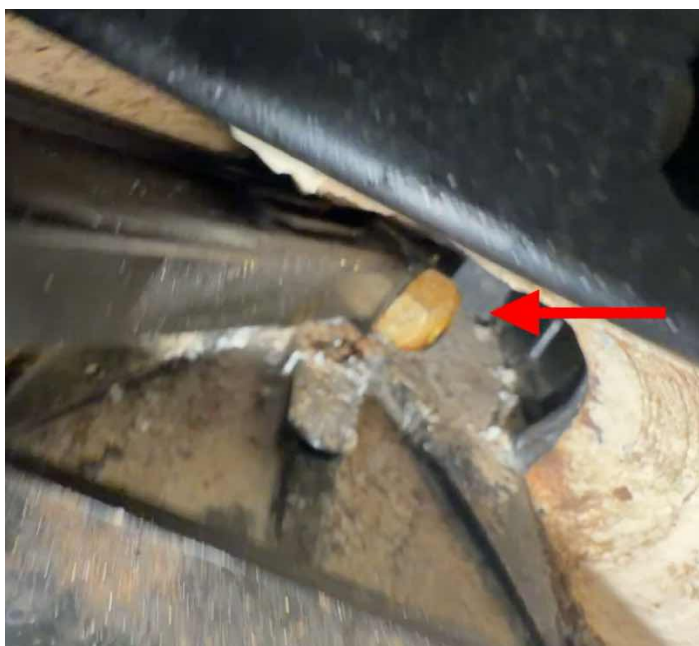
| Trim Cylinders | Good condition, no leaks sighted | Transom / Steering Wear | Moderate amount of wear, recommend replacing steering pin & bushes |

L29. Corrosion to transom assembly steering pin, moderate play noted to steering bushes

L29. Corrosion to transom assembly steering pin
