# INSURANCE INSPECTION OUT OF WATER

2023 Capelli Tempest 38

| Date | 06/02/2026 |

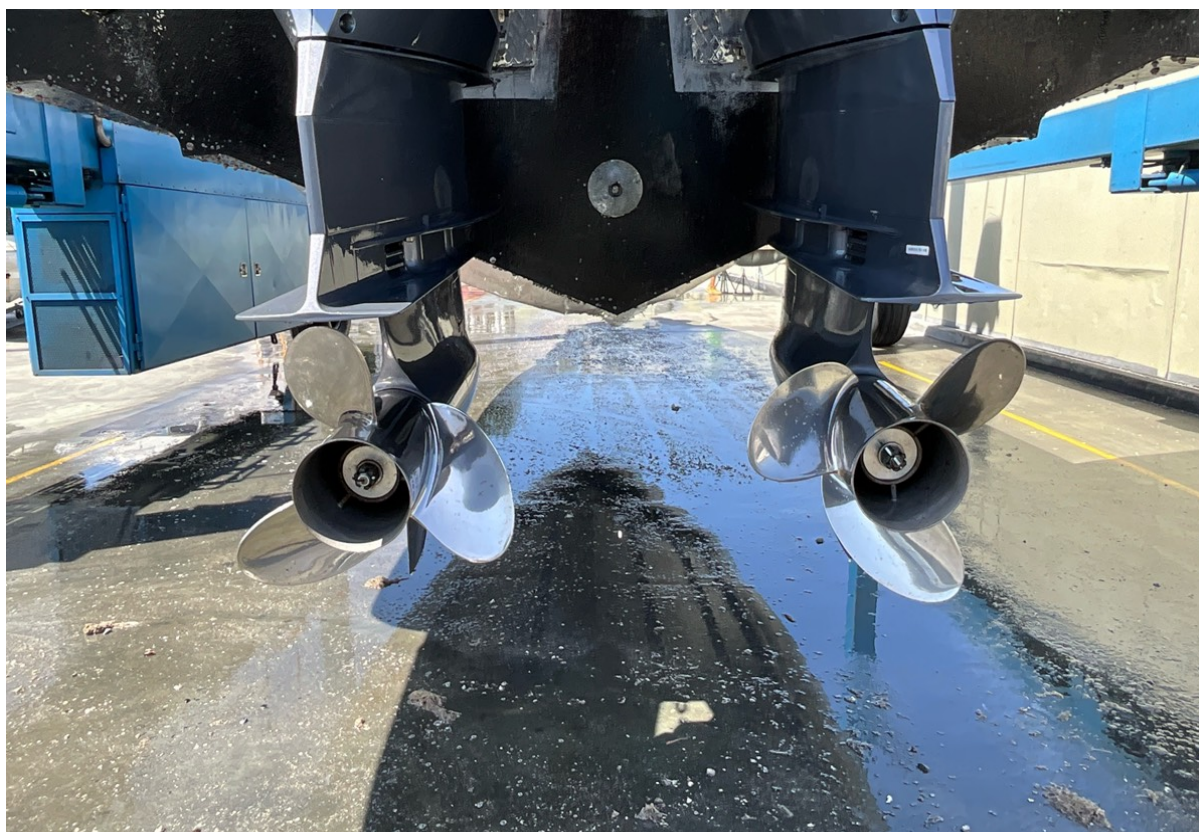
Propellers/Running Gear

| Propellers | 3-Blade stainless steel propellers in good condition<br>Counter rotating<br>21<br>16 3/8 | Shaft/s | Located behind propellor, can not access |
