# Seaworthy Inspection Report

Date of Survey 31 Jan 2025 10:18 AEDT

Reason For Survey Pre-Purchase Survey

Vessel Make and Model Caribbean Safari

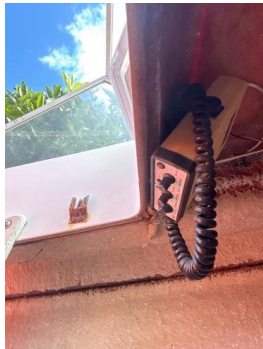
Photo 79

Poor

not powering up

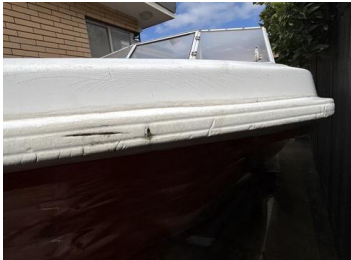
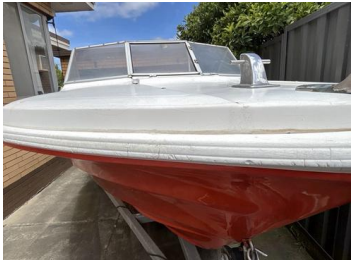
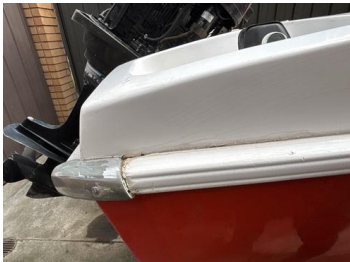
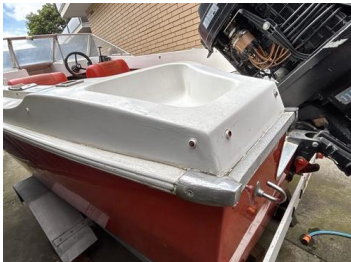
Scuffs cuts and some age cracking mostly intact all around

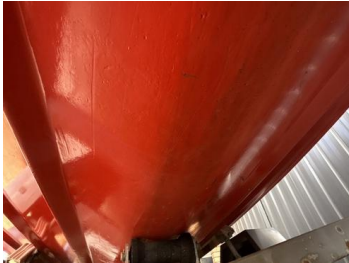
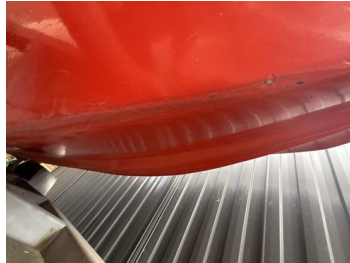
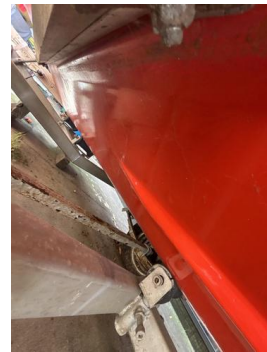
Satisfactory

A few small chips

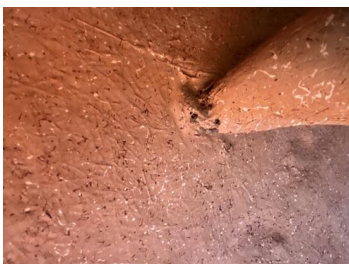
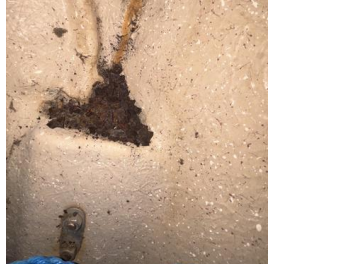
No access to stringers and underfloor compartments mostly - internal transom and restrung area showing no signs of delamination.

Deck solid underfoot - had professional work in the centre deck area refurbishment

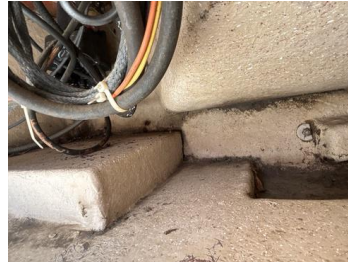
Photo 48

Percussion testing showing no signs of delamination - transom exceptional condition for age of vessel

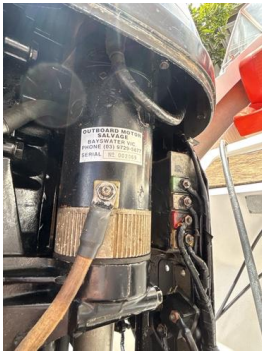
Photo 65

| Inspected | Satisfactory |

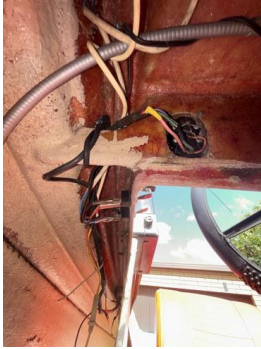
Photo 74

Fair

Overall basic functional however aged wiring.

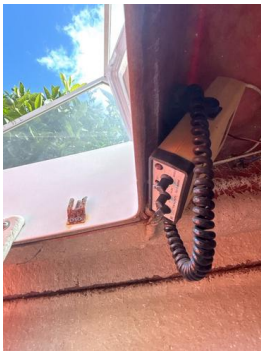
Photo 79

Poor

not powering up

Elevate safety equipment on board i.e. flares and extinguishers.  
Recommend engine service for clean slate of gear oil and impeller before use.  
Recommend installation of bilge pump.  
Recommend fastening of battery with box or clamp housing.  
Consider replacing trailer winch with modern day type for easy of use.  
In my opinion this package is an insurable boat asset.

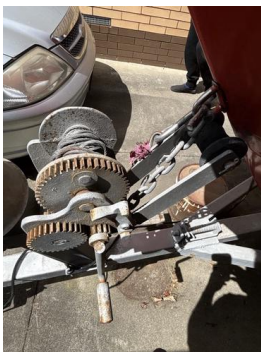
Photo 82

Fair

Aged - functional

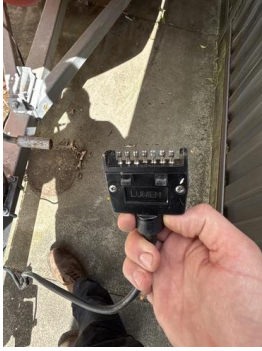
Photo 83

Powered Up

Satisfactory
